Hydrogeological Assessment

FINAL REPORT

Hunter Farm Development
Marion Street
Dorchester, Ontario

LON-21008138-A0

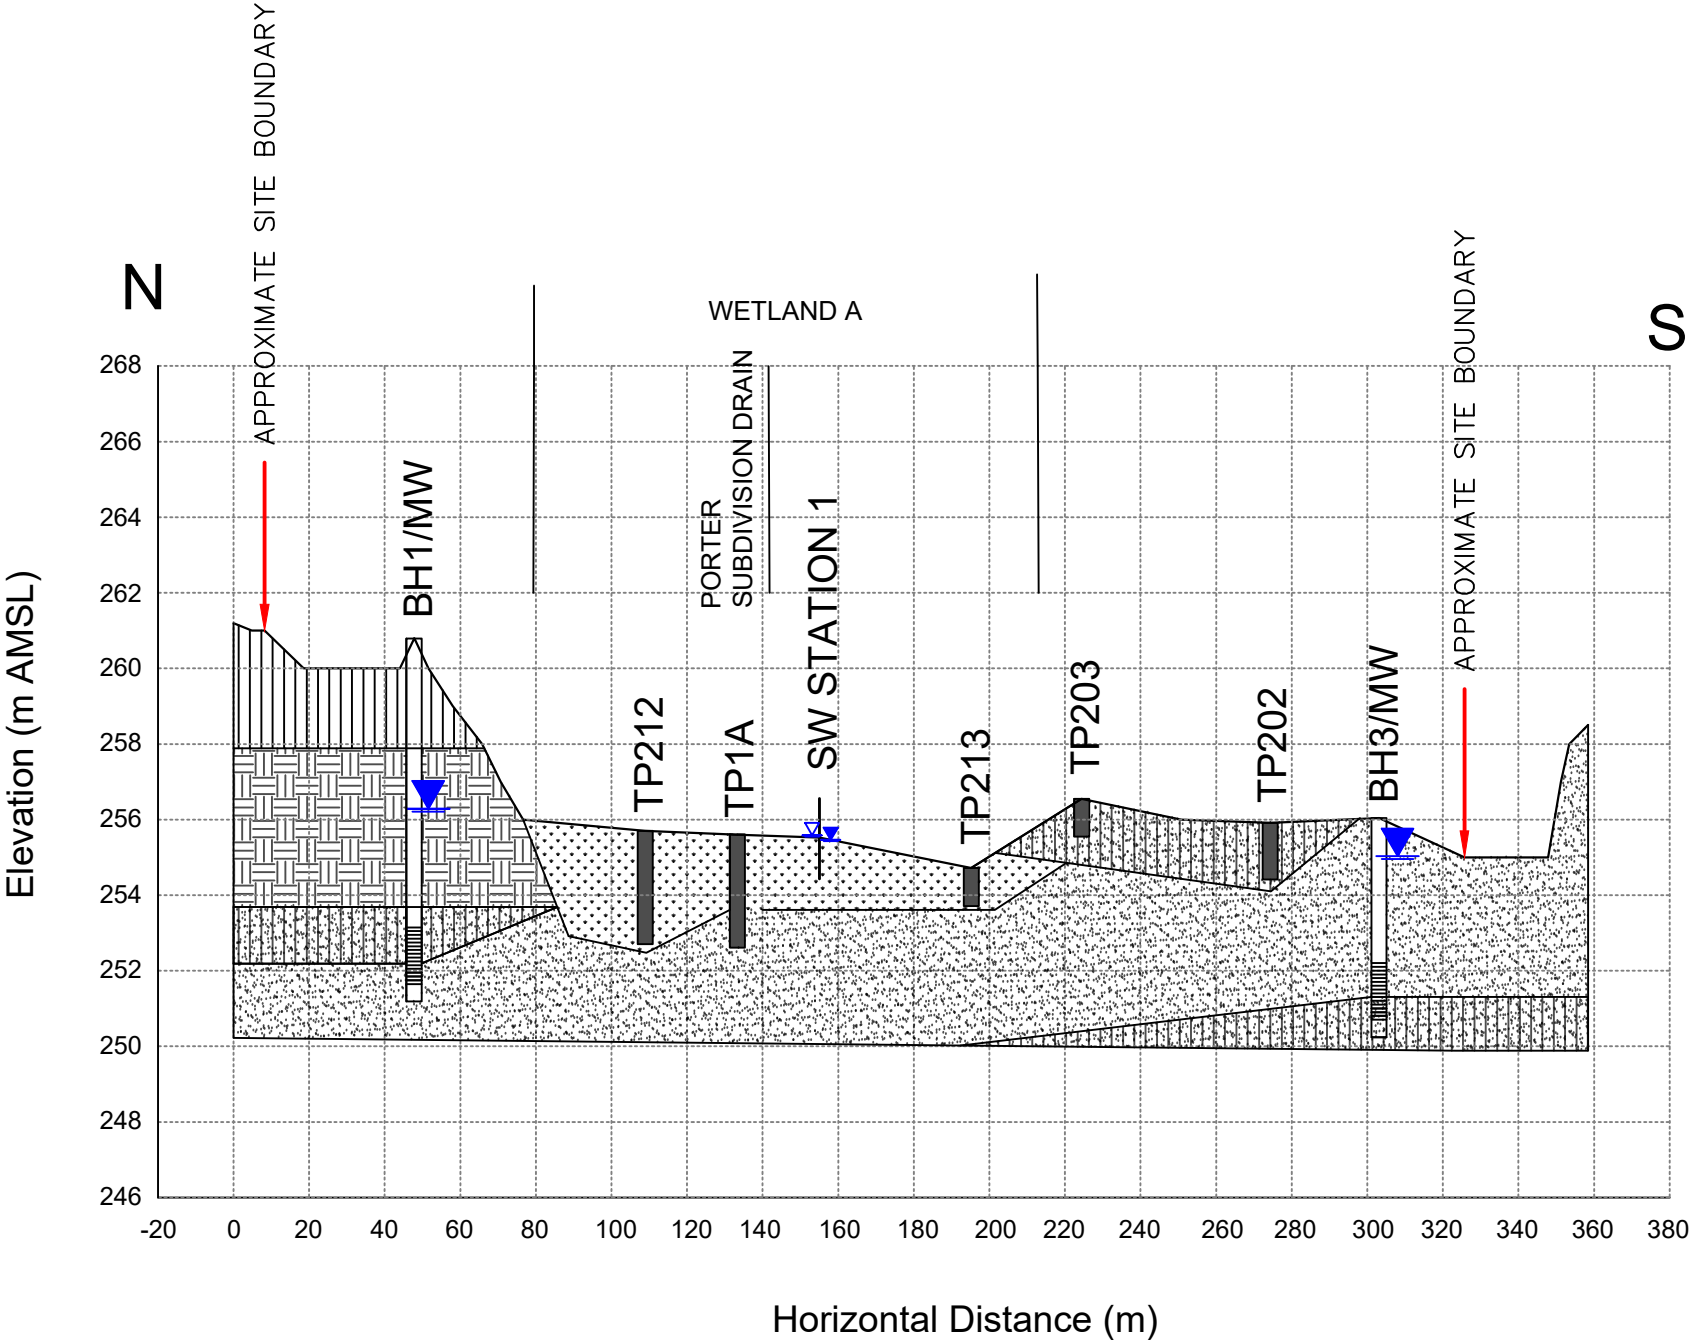
CROSS SECTION C-C'

As shown in cross section C-C’ (**Drawing 12**), the western portion of the Site consists of surficial silt, silty sand/sandy silt and silt clayey/till overlying sand and sand and gravel. This sand layer becomes exposed at surface at the southwest portion of the Site around BH3/MW. Based on borehole logs, the sand layer is up to 4.5 m thick (BH3/MW). Surficial organic deposits were noted in the vicinity of Wetland A.
